**Proposed Residential Development at  
Elmfield, Clondalkin, Dublin 22**

**Stage 1 Quality Audit Report**

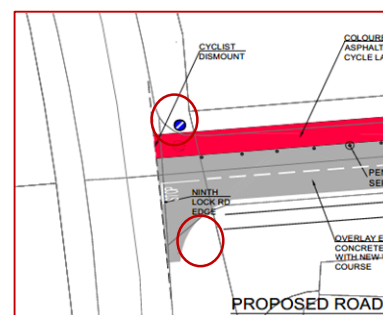
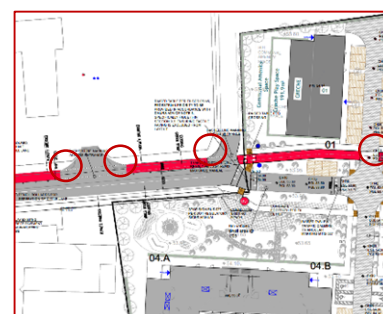
Absence of tactile paving was noted at a number of locations within the proposed development, and also within the existing road layout on Oakfield and Ninth Lock Road, including:

Appropriate tactile paving should be provided at the retained dropped kerbs at the existing uncontrolled pedestrian crossings on Oakfield, and along pedestrian desire lines within the proposed development, where not currently indicated.

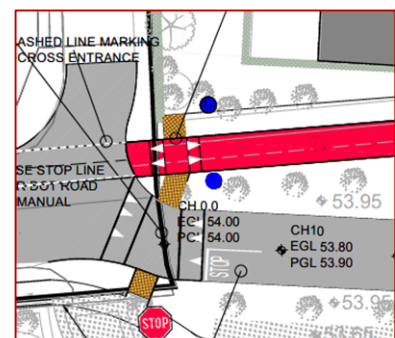
### A.1.5 Tactile Paving Arrangement at Cycle Track Crossing

A raised cycle track crossing and raised carriageway crossing are proposed adjacent to each other at the access to the proposed development. The tactile paving on the southern side of the cycle track crossing is indicated as connecting with the tactile paving on the northern side of the raised carriageway crossing, such that it is laid across the full length of this short footpath link. The tactile paving layout on the southern side of the carriageway crossing also does not align with the tactile paving at the crossing across the cycle track. In addition, the tactile paving on the northern side of the cycle track crossing is indicated across the full depth of the footpath.

The tactile paving layout at both of these crossings may lead to confusion for visually impaired pedestrians resulting in them being unable to safely and independently navigate the road layout.

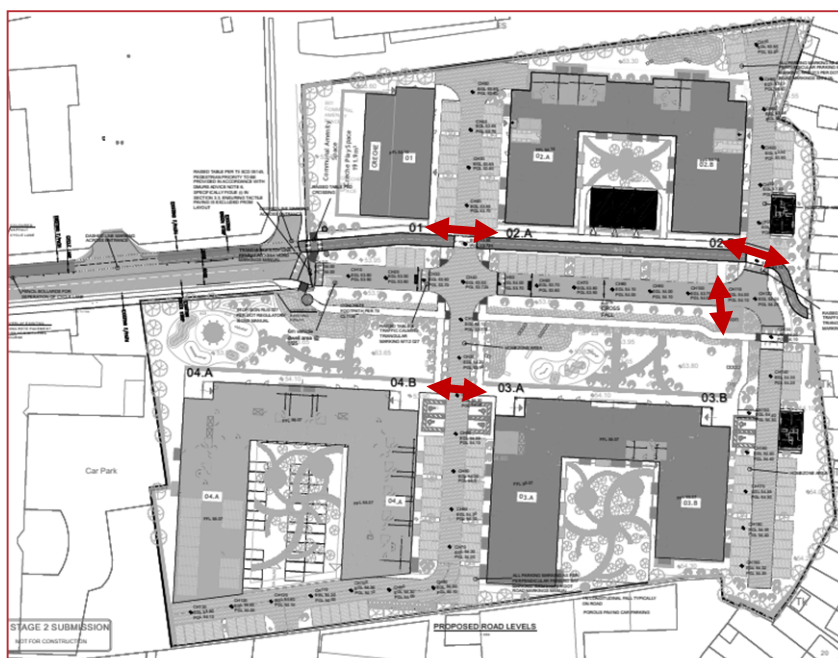
## A.1.8 Pedestrian Crossing Desire Lines

A failure to provide pedestrian crossings along likely pedestrian desire lines, including where these are across the proposed cycle track, may lead to difficulties for the visually and mobility impaired, particularly wheelchair users, when crossing the carriageway or cycle track.

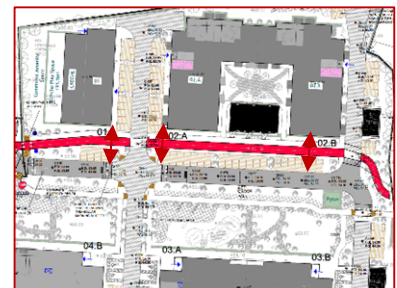
A cycle track is indicated running through the proposed development in an east to west direction. There are a number of pedestrian desire lines across the cycle track between the parking spaces on the southern side of the cycle track and the footpath on the northern side of the cycle track which are not catered for with a crossing. Absence of crossings across the cycle track at these pedestrian desire lines may lead to mobility impaired vehicle occupants, parked on the southern side of the cycle track, being unable to safely and independently cross the cycle track to access the footpath.

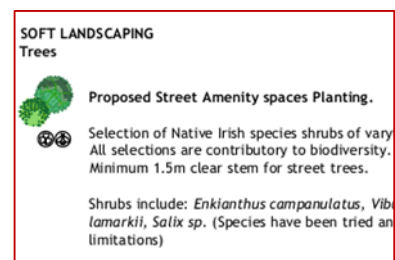
Trees have been indicated at the edge of the footpaths throughout the proposed development. A minimum clear stem of 1.5m for trees within the development has been indicated. This clearance beneath tree canopies would be insufficient for trees that overhang footpaths. Low hanging tree canopies may impede pedestrians travelling on the footpaths, resulting in a risk of head strikes and personal injury.

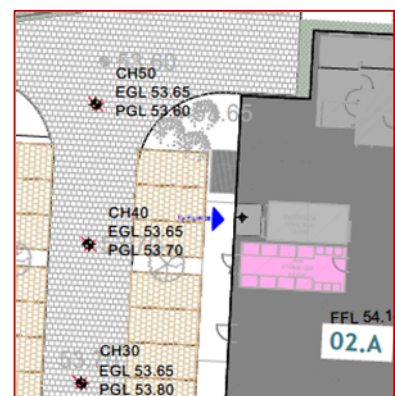
Home Zones have been indicated throughout the proposed development. It is unclear how pedestrians would access the footpath on both sides of the Home Zone carriageway in some of these Home Zones as there is a verge indicated between the footpath and the Home Zone carriageway. A verge separating the footpath and Home Zone carriageway would present a barrier for pedestrians when accessing the footpath, leading to them either trying to cross the verge to access the footpath or having to travel longer distances to a suitable access.

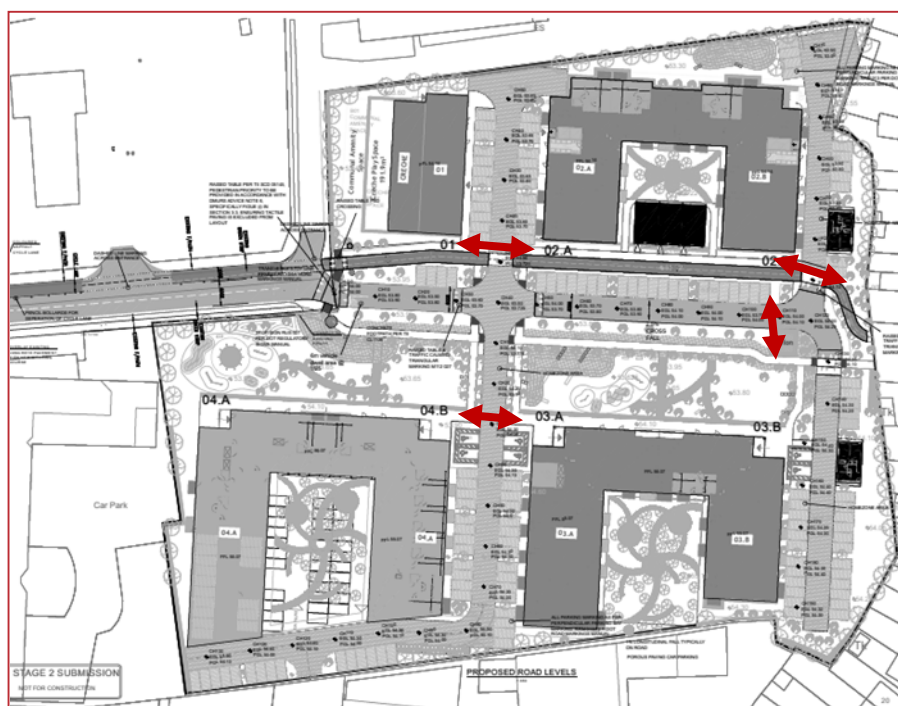
## B.1.4 Pedestrian Crossing Desire Lines

There is likely to be a number of pedestrian desire lines within the proposed development, including between the residential units and the areas of open space and across side roads at the development's internal junctions.

A failure to provide pedestrian crossings along likely pedestrian desire lines, including where these are across the proposed cycle track, may lead to pedestrians having to ascend/descend high kerbs when crossing the carriageway or cycle track.

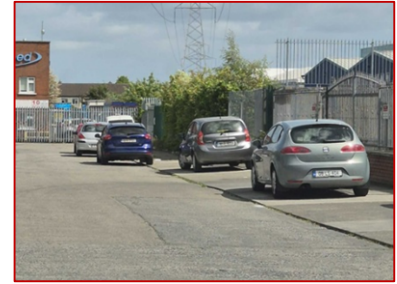
### **B.1.6 On-Street Parking on Oakfield**

During the site visit, a number of vehicles were noted parked within, or partially within, the footpath on the southern side of Oakfield. On-street parking within the footpath at this location may force pedestrians to travel within the carriageway to avoid the parked vehicles.

Provide measures to deter parking within the footpath on the southern side of Oakfield.

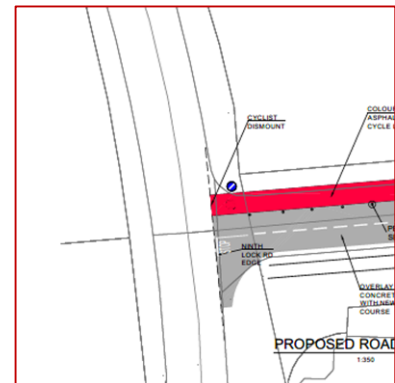
### C.1.4 Termination of Cycle Track

In addition, it is unclear how the cycle track will tie in with the adjacent development at its eastern end. There is a concern that eastbound cyclists may have to continue their journey within the adjacent grassed area, which may present loss of traction, and bicycle control, issues for cyclists.

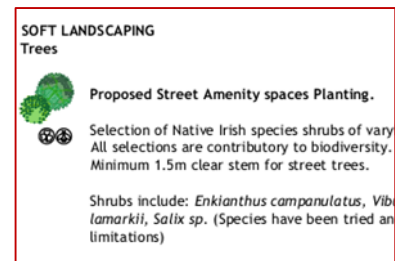
Trees have been indicated at the edge of the cycle track within the proposed development. A minimum clear stem of 1.5m for trees within the development has been indicated. This clearance beneath tree canopies would be insufficient for trees that overhang the cycle track. Low hanging tree canopies may impede cyclists travelling on the cycle track, resulting in a risk of head strikes and personal injury.

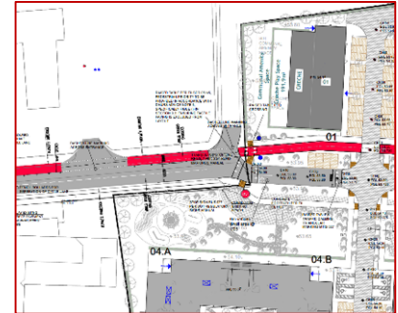
This may lead to drivers being insufficiently aware of the potential for approaching cyclists when approaching, and stopped at, the accesses resulting in them failing to take due care and consideration to approaching cyclists when entering/exiting and an increased risk of vehicle-cyclist collisions.

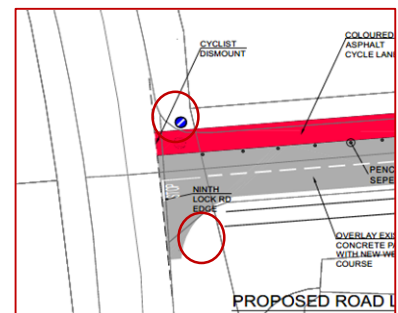
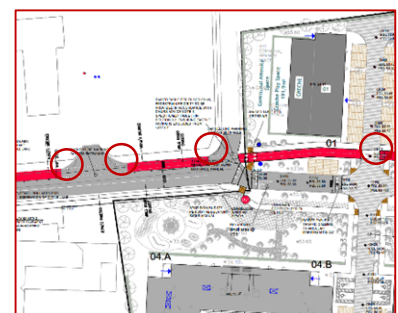
The existing footpaths on both sides of Oakfield are indicated as being retained however the dropped kerbs on both sides of the existing accesses on this road do not currently include tactile paving, nor is any indicated as part of the proposed scheme. There is also no tactile paving provided across the Oakfield/Ninth Lock Rd Junction. A failure to provide tactile paving at road/access crossings on the existing pedestrian desire lines may lead to visually impaired pedestrians inadvertently entering the carriageway, increasing the risk of vehicle-pedestrian collisions.

There is also a likely pedestrian desire line across the northern arm of the crossroad junction, within the proposed development, where no tactile paving has been indicated. An absence of tactile paving at road crossings within the development may lead to visually impaired pedestrians being insufficiently aware they are entering a Home Zone, increasing the risk of collisions with other road users.

In addition, no tactile paving has been indicated where the carriageway transitions to Home Zone carriageways throughout the development. An absence of tactile paving at these transitions may lead to visually impaired pedestrians being insufficiently aware that they are entering a Home Zone, increasing the risk of a collisions with other road users.

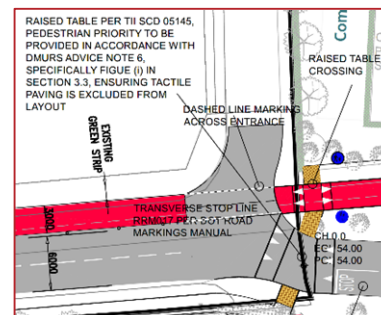
If road user priority is not clear from the road layout it may lead to confusion for road users regarding who has priority at the crossing, resulting in a risk of vehicle-pedestrian collisions.

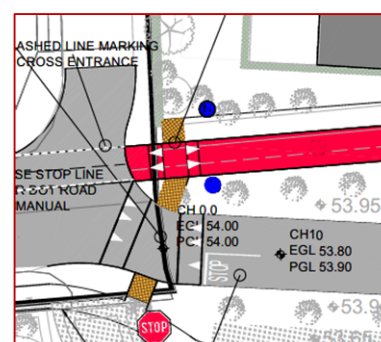
A raised cycle track crossing and raised carriageway crossing are proposed adjacent to each other at the access to the proposed development. The tactile paving on the southern side of the cycle track crossing is indicated as connecting with the tactile paving on the northern side of the raised carriageway crossing, such that it is laid across the full length of this short footpath link. The tactile paving layout on the southern side of the carriageway crossing also does not align with the tactile paving at the crossing across the cycle track. In addition, the tactile paving on the northern side of the cycle track crossing is indicated across the full depth of the footpath.

The tactile paving layout at both of these crossings may lead to confusion for visually impaired pedestrians resulting in them being unable to safely and independently navigate the road layout.

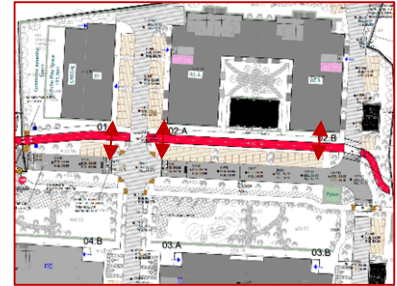
A cycle track is indicated running through the proposed development in an east to west direction. There are a number of pedestrian desire lines across the cycle track between the parking spaces on the southern side of the cycle track and the footpath on the northern side of the cycle track which are not catered for with a crossing. Absence of crossings across the cycle track at these pedestrian desire lines may lead to trips and falls as pedestrians cross the cycle track.

In addition, a lack of formal crossings across the cycle track at these desire lines may also lead to mobility impaired vehicle occupants, parked on the southern side of the cycle track, being unable to safely and independently cross the cycle track to access the footpath.

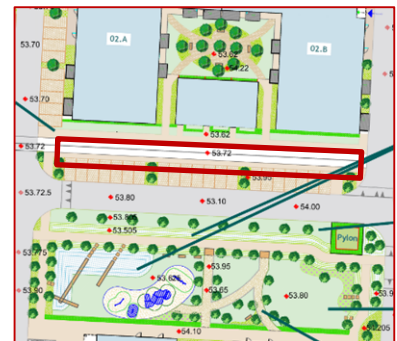
Insufficient footpath width at this location may force pedestrians into the cycle track, after exiting their vehicle, where there is an increased risk of cyclist-pedestrian collisions.

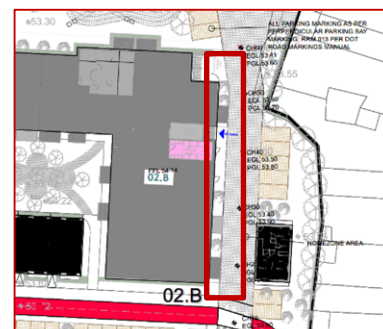
In addition, it is unclear what the grey rectangles are which are indicated within the footpath adjacent the Home Zone carriageways. Trees, and these rectangles, indicated within these areas, would likely reduce the effective width of the footpath which may force pedestrians into the Home Zone carriageway where there is an increased risk of pedestrian-cyclist and vehicle-pedestrian collisions.

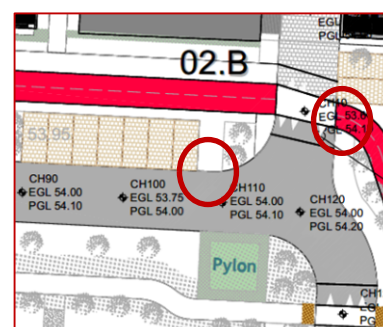
There are sections of footpath which terminate at the edge of the carriageway and at the edge of the cycle track at the easternmost junction within the proposed development. Abrupt termination of the footpath at the edge of the carriageway or cycle track may lead to visually impaired pedestrians tripping at the kerb, or inadvertently entering the carriageway or cycle track, where there is risk of pedestrian-cyclist, or vehicle-pedestrian collisions.

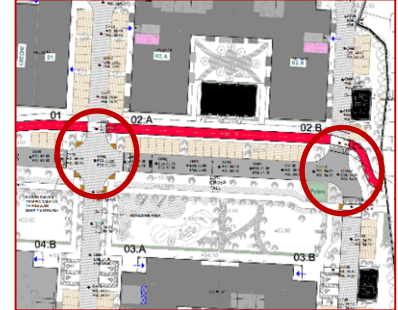
The junction control (stop, yield etc.), and thus priority, at the crossroad junction and the easternmost junction within the proposed development has not been indicated. It is, therefore, unclear who has priority at these junctions. This could lead to driver confusion and hesitation resulting in collisions should opposing drivers assume that they have priority over vehicles on adjacent roads and enter the junctions simultaneously.

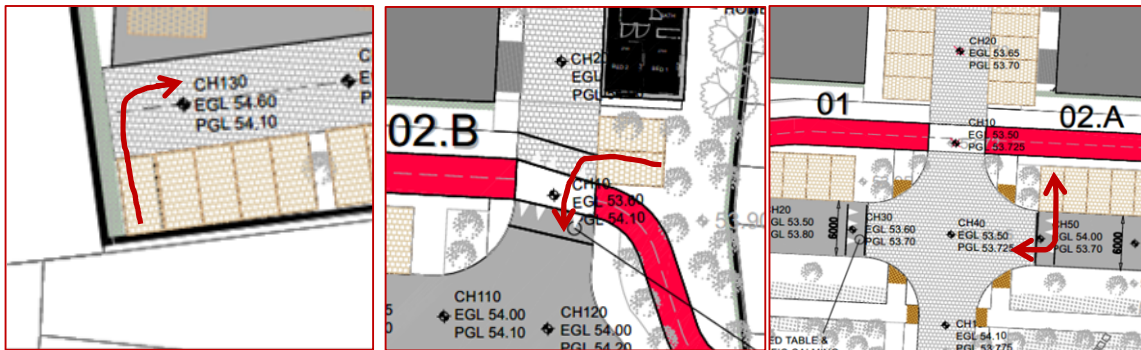
**Summary:** *It is unclear if drivers will be able to safely enter/exit the proposed parking spaces adjacent the raised junctions within the development, and at the westernmost parking space to the south of Apartment Block 04.A.*

It is unclear if drivers will be able to safely enter/exit the proposed parking spaces adjacent the raised junctions within the proposed development, and at the westernmost parking space to the south of Apartment Block 04.A, due to a combination of the proximity to the boundary and the angle of the carriageway, or junction.

If sufficient space is not provided at these parking spaces for safe access/egress, it may lead to drivers having to undertake complex turning manoeuvres, resulting in material damage collisions, to access/exit the parking spaces, particularly if the adjacent parking spaces are occupied.

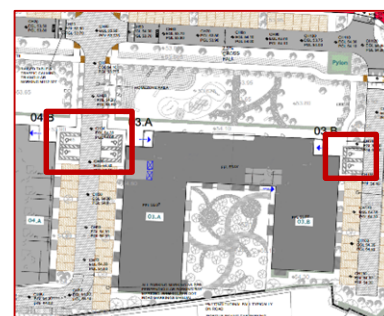
There are a number of accessible parking spaces indicated within the Home Zones in the proposed development. It is unclear if the accessible parking spaces within the Home Zones are level with the adjacent footpath and, if a level difference is provided, mobility impaired vehicle occupants may experience difficulties travelling between the footpath and their vehicle resulting in them having to travel within the carriageway, where there is an increased risk of being struck by a vehicle.

However, if a level difference is intended between the parking spaces and footpath, however, no dropped kerbs and tactile paving have been indicated at the accessible parking spaces.

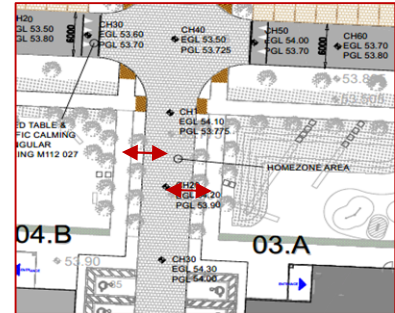
In addition, pedestrians that try to cross the verge to access the footpath may slip and fall on the grass, and sustain personal injuries, particularly during icy conditions.

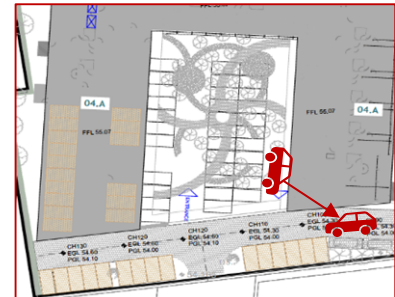
If the carpark is at surface level, it is unclear if there would be sufficient inter-visibility between a driver exiting the carpark and a westbound vehicle, cyclist or pedestrian travelling along the Home Zone carriageway.

Restricted inter-visibility at the exit from the carpark may lead to exiting drivers being insufficiently aware of the other road users travelling along the Home Zone resulting in them exiting when it is unsafe to do so and collisions with other road users.

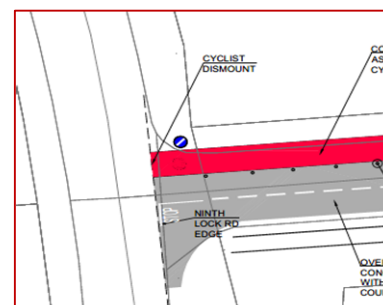
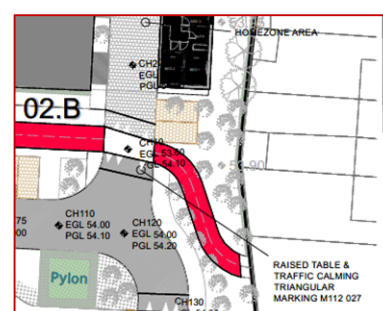
It is also unclear how cyclists would access the cycle track from the existing road layout on Ninth Lock Road at its western tie-in. The absence of a safe tie-in with the existing road layout on Ninth Lock Road may lead to cyclists undertaking unsafe manoeuvres between the Ninth Lock Road and the cycle track, resulting in a risk of vehicle-cyclist collisions.

In addition, if the cycle track is proposed to be two-way, it is unclear if the width of the cycle track, particularly at its eastern extents, would be wide enough to accommodate two-way cyclist volumes. Insufficient width of the cycle track for two-way flow may lead to an increased risk of collisions between cyclists.

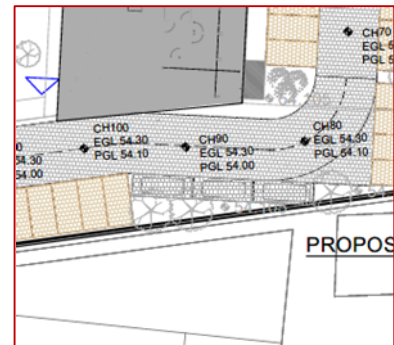
### 3.18 Absence of Tapers at Parallel Parking Spaces

**Summary:** No tapers have been indicated at the ends of the parallel parking spaces which may lead to material damage collisions as drivers attempt to enter/exit these spaces.

Parallel parking spaces have been indicated at the southern extents of the proposed development within the Home Zone between Apartment Blocks 04.A and 03.A. No tapers have been indicated at the ends of these parallel parking spaces. An absence of tapers at the ends of the parallel parking spaces may lead to drivers being unable to enter/exit the parking spaces if the adjacent spaces are occupied, resulting in material damage collisions.

| # | | | | | Summary of Audit Issue | Design Team Response/Action |
|---|--|--|--|---|---|---|
| 29 | | | | ✓ | No tapers have been indicated at the ends of the parallel parking spaces which may lead to material damage collisions as drivers attempt to enter/exit these spaces. | 5mx2.5m spaces are considered adequate for parking. an auto turn maneuver has been added. |

Provide tapers at both ends of the row of parallel parking spaces.

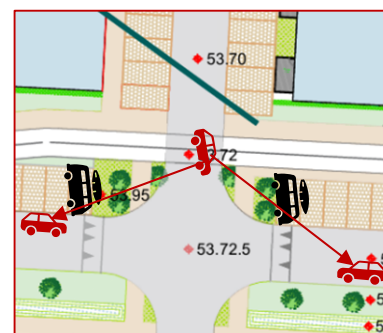
It is unclear if a southbound driver on the northern arm of the crossroad junction within the proposed development would have sufficient inter-visibility with westbound or eastbound drivers/cyclists approaching the junction on the eastern or western arms. Trees are indicated within the verges on both sides of the northern arm which may restrict inter-visibility between opposing road users resulting in a risk of side-on collisions should opposing road users enter the junction simultaneously.

In addition, if a high-sided vehicle is parked in the parking spaces on either side of the crossroad junction, this would further restrict the inter-visibility between road users.

#### Recommendation

Ensure sufficient inter-visibility is provided between all road users approaching the crossroad junction, on all arms.

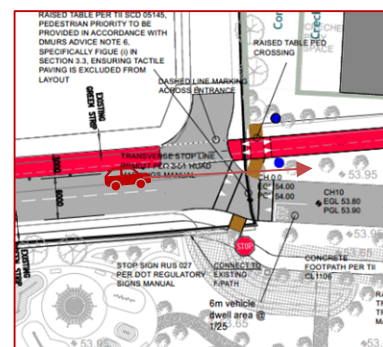
**Summary:** *It is unclear if eastbound drivers on Oakfield would anticipate the change in direction in the horizontal alignment at the access to the proposed development, which may lead to them entering the verge or footpath, resulting in a risk of vehicle-pedestrian collisions.*

The alignment of the existing Oakfield carriageway does not align with the proposed alignment of the carriageway at the access to the proposed development. Eastbound drivers travelling along Oakfield, using the edge of the cycle track to maintain their position within the traffic lane, may continue along that line of travel and fail to negotiate the sudden change in horizontal alignment at the access, resulting in them entering the verge or footpath/uncontrolled crossing, where there is a risk of collisions with pedestrians.

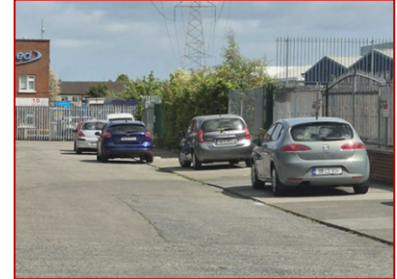
During the site visit the Audit Team noted a number of vehicles parked within, or partially within, the footpath on the southern side of Oakfield. On-street parking within the footpath at this location may force pedestrians to travel within the carriageway to avoid the parked vehicles, where there is a risk of them being stuck by a vehicle.

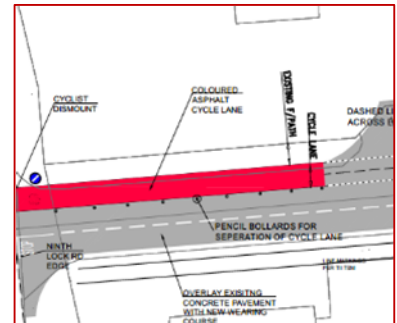
**Summary:** *Insufficient lateral clearance between the bollards at the edge of the cycle track and the adjacent traffic lane may lead to drivers/cyclists striking the bollards, resulting in material damage or personal injuries.*

Pencil bollards are indicated between the cycle track and eastbound traffic lane on Oakfield. It is unclear from the drawings provided, however, what the proposed lateral clearance is between the bollards and the cycle track and adjacent traffic lane. Insufficient lateral clearance between the cycle track and traffic lane may lead to cyclists, or drivers, striking the bollards, resulting in personal injuries or material damage, respectively.

| # | | | | | Summary of Audit Issue | Design Team Response/Action |
|---|---|---|---|---|---|---|
| 18 | | ✓ | | ✓ | Insufficient lateral clearance between the bollards at the edge of the cycle track and the adjacent traffic lane may lead to drivers/cyclists striking the bollards, resulting in material damage or personal injuries. | Works on the Oakfield Rd are being omitted. This road is in private ownership. New drawings to issued. Drawings updated to reflect this. |
